Sealant Removal from an A-10 Thunderbolt Center Wing Fuel Tank Using a Portable Hand-Held Nd:YAG Laser System

Norman J. Olson
Pacific Northwest National Laboratory
Richland, Washington 99352

Mitchell Wool
General Lasertronics Corporation
San Jose, California 95112

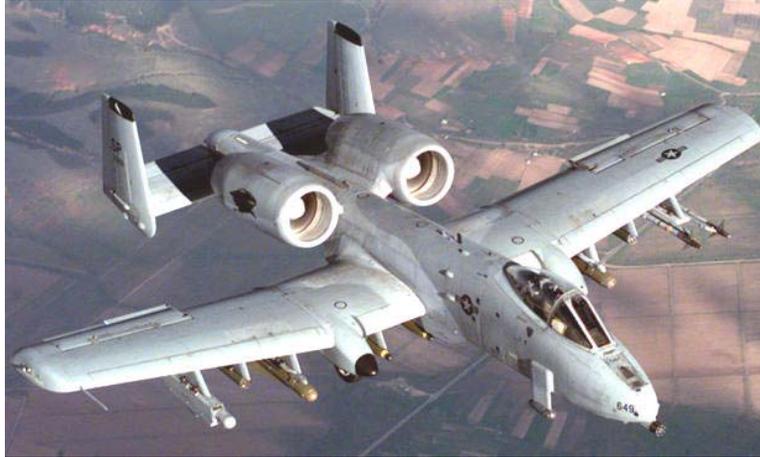
Figure 1. A-10 Thunderbolt ready for action

More than 350 A-10 Thunderbolt aircraft (Warthogs) are in service with the U.S. Air Force, Air Combat Command, the U.S. Air Force Reserve, and the Air National Guard (Figure 1). The maneuverability of these aircraft at low speed and at low altitude (below 1,000 feet) allows accurate and effective targeting and weapon delivery over all types of terrain. Such maneuverability in close-range targeting situations also leads to structural stress.

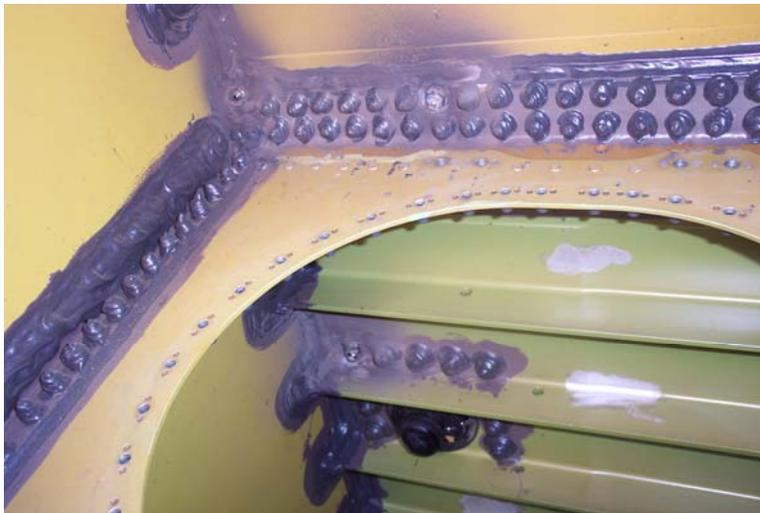
Periodically, center wing tanks require inspection for structural defects. The A-10 center wing tanks have sealant (e.g., Military Specification 8802-Polysulfide) covering fastener areas to eliminate fuel leakage (Figure 2).

Figure 2. Sealant covering fasteners in the center wing tank

When fuel tanks leak or when critical non-destructive examinations or repair of these areas is necessary, the traditional method is to remove sealant manually by mechanical means (scraping). This method is time-consuming and tedious due to the irregular geometries of the fastener regions. The confined space makes the task even more difficult. Incomplete cleaning is highly likely and mechanical scraping can also damage the structure if adequate care is not taken (Figure 3). Each A-10 has eight cells like those shown in Figures 2 and 3 in the center wing tank, and each cell has about 600 sealant-covered fasteners.

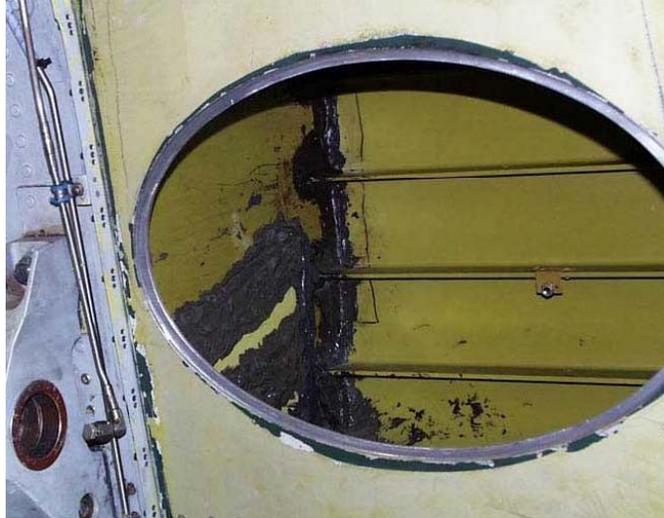
Figure 3. Example of results of mechanical (scraping) to remove sealant

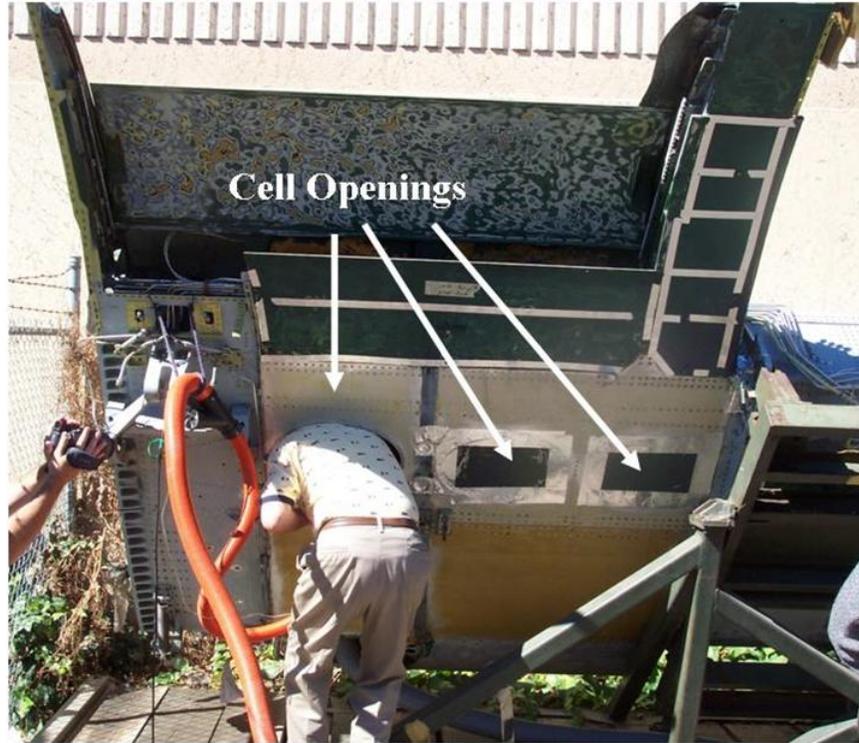
Figure 4. Port half of the retired center wing tank showing fuel cell openings are barely large enough for an operator

Air is blown at a rate of approximately 25 cfm through the umbilical hose (orange hose in Figures 4, 6, and 7), through the tool, and out the laser beam aperture. The air provides cooling for the optics, electronics, and mechanical components in the tool as well as protects the optics from intrusion by sealant particles from the ablating surface. Additionally, the air reduces the concentration of combustible vapors during sealant removal to a point well below the Lower Flammability Limit (LFL). The umbilical length was approximately 100 feet, so the laser and air blower can be located a significant distance from the aircraft (Figure 4).

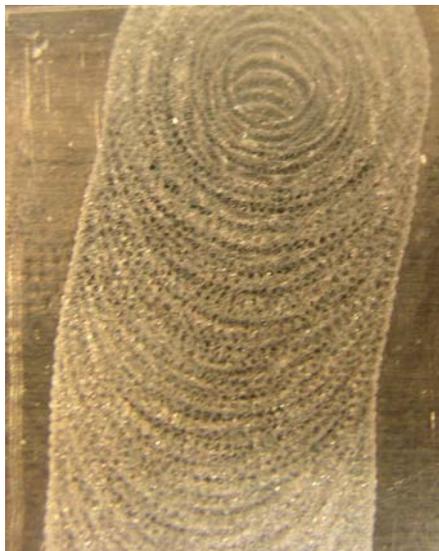
For this confined space application, a tool developed by GLC, based on a patent that GLC filed under AF SBIR Topic No. 98-270, was modified to fit within an end-effector configuration that is 2.6 inches in diameter and 8 inches in length. The tool contains the beam-scanning mechanism and optics to focus the beam onto the user-selected surface location in a two-dimensional spiral scan pattern. The pattern was selected to avoid substrate damage and to ensure complete and systematic coating removal (Figure 5).

Figure 5. *Typical spiral scan used*

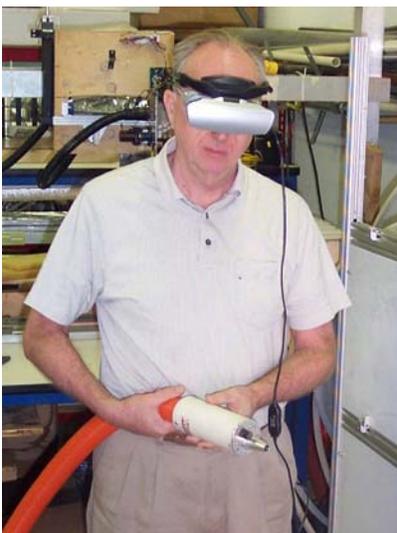
In addition, the tool carries a miniature camera that provides a video feed to a head-mounted display (Figure 6).

Figure 6. *Operator uses video display if line-of-sight obstructions exist*

While wearing the display unit, the operator can see a surface spot where the laser is removing material even if line-of-sight obstructions exist in the wing tank. The end effector, its aperture, the video camera, and the optical fiber umbilical hose are shown in Figure 7.
